# Manhole Inspection Summary

Manhole # S21M1\_016MH

Insp Date: **4/30/08 10:32 AM**

**Location** Address: **3220 hollins ferry rd**

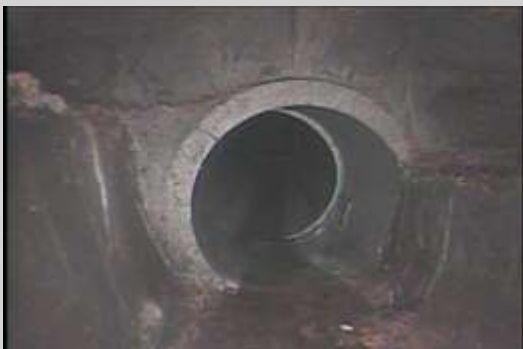
6 O'Clock Inflow

8 in. Circular Gravity Sewer  
Pipe In @ 6 O'Clock

Pipe Height: **8.4** (in.) Rod and Bar (Angled)  
Pipe Material: **Clay** ☐ Pipe Lined  
Invert Depth: **14.48** (ft.) Flow Characteristics: **Slow**  
Deposits: ☒ None ☐ Mud ☐ Sludge ☐ Debris ☐ Grease  
Silt Depth: **0** (in.) Deposits Extent:  
Infiltration: **None** Pipe Seal Cond: **Sound**
